MEDICINE RIVER AQUIFER COMPLEX AT RISK

by Dale Christian (MFAC)

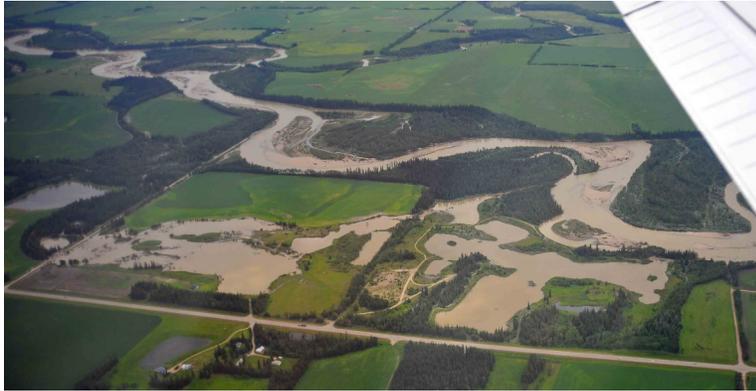
An example of the flooded (captured) pits in the flood of 2013 - pits both described as extracted above (left side) and below (right side) the water reservoir taken (about 480 acres).

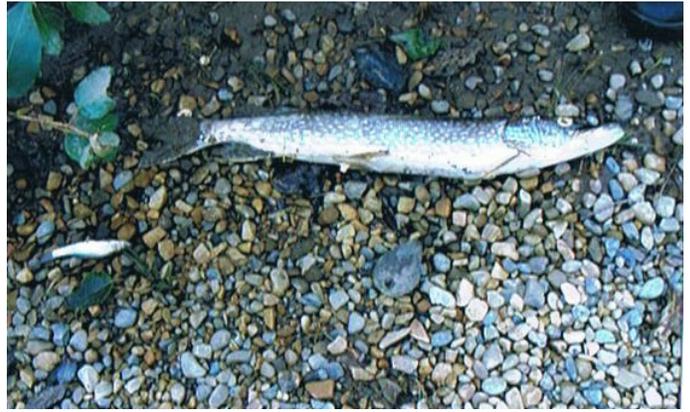
One of the stranded large pike found in the ditch in 2014. The water was running out of the pits back to the Red Deer River.

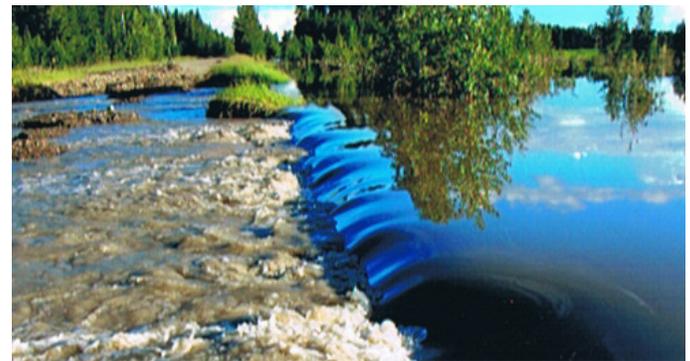
This is what happened to RR20 south in 2013 - (the same as in 2005 and 1990). On the right side you can see the captured pit area where the Red Deer river is flooding through the road. The people on the left side have been bought out recently as their foundation was washed away and they were stranded for three weeks.

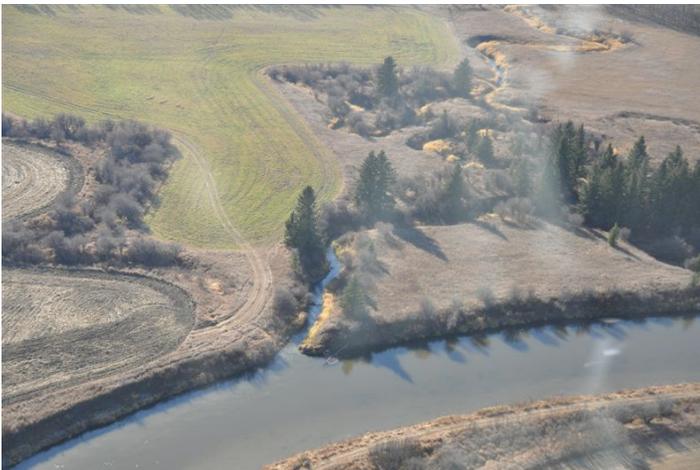
This pictures shows the Dickson Creek/Medicine River confluence late in the fall - you can see the other vegetated area stream was bermed off. However, it is still deemed Crown Land.

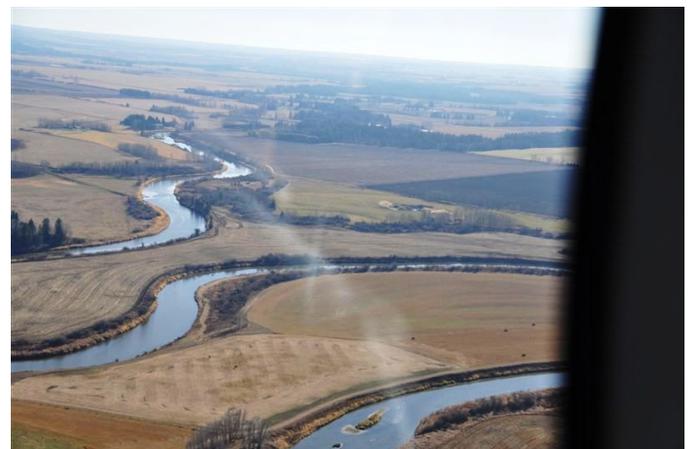
This is the area which the last gravel application was for. You can see where 6M was already gravelling out (look at the area just south of the vegetated strip). This area is subject to spring flooding at the existing elevation. You might be able to see why we think lowering it would cause a river cut across leaving the loop stranded!
